EXERCISE DESERT ROCK LAS VEGAS NV

EXERCISE DESERT ROCK V. JANUARY-JUNE 1953. VOLUME I. OPERATIONS--ETC(U)

Exercise Desert Rock V

Volume I - Operations

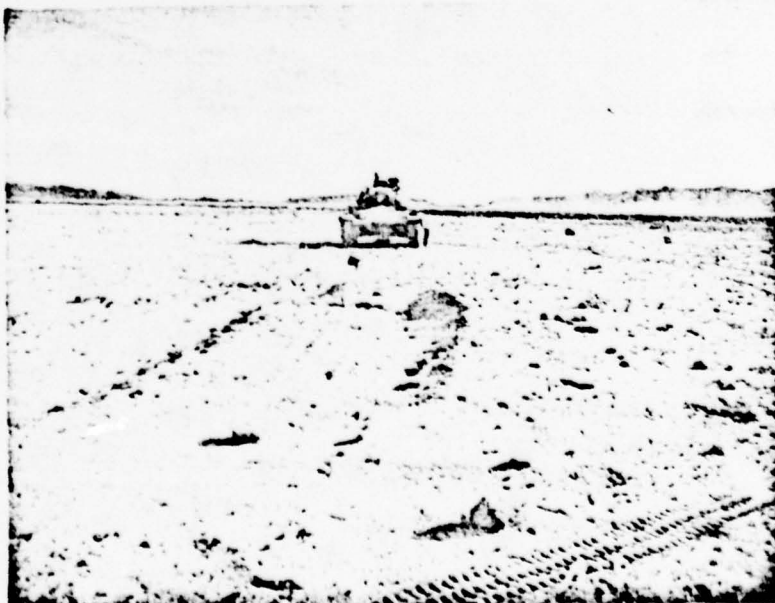
Vehicle pushed
straight back 60 ft.
Front of vehicle
burned interior wir-
ing ripped loose

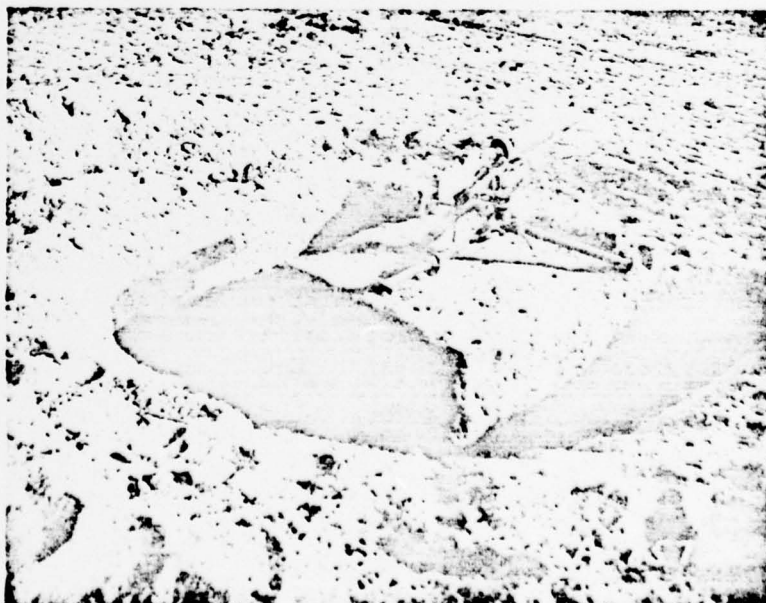
No visible damage

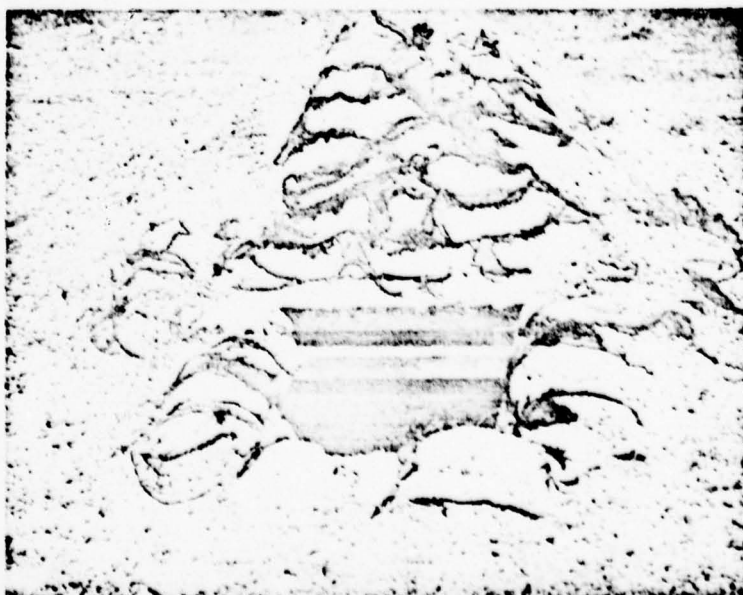
C-4 1,000 yds. All
sand bags needed re-
placing. Structure
slightly damaged &
full of sand.

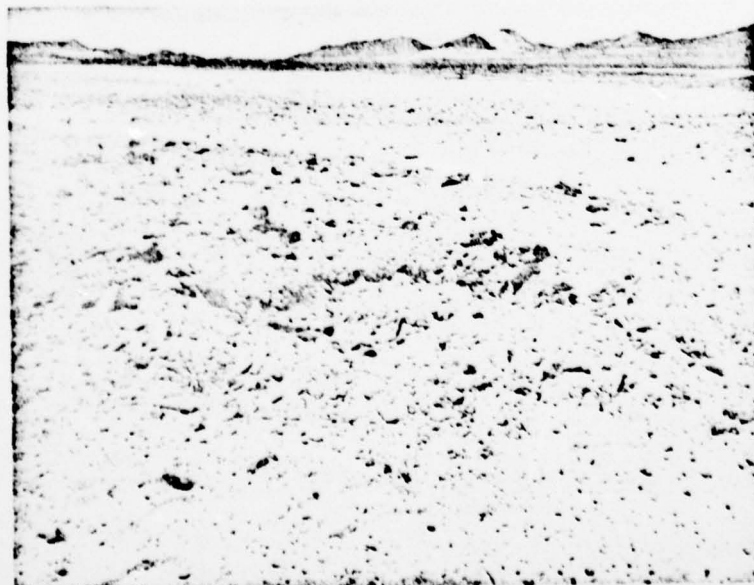
Blown out of emplace-
ment. Barrel and jack-
et bent. Damaged be-
yond repair.

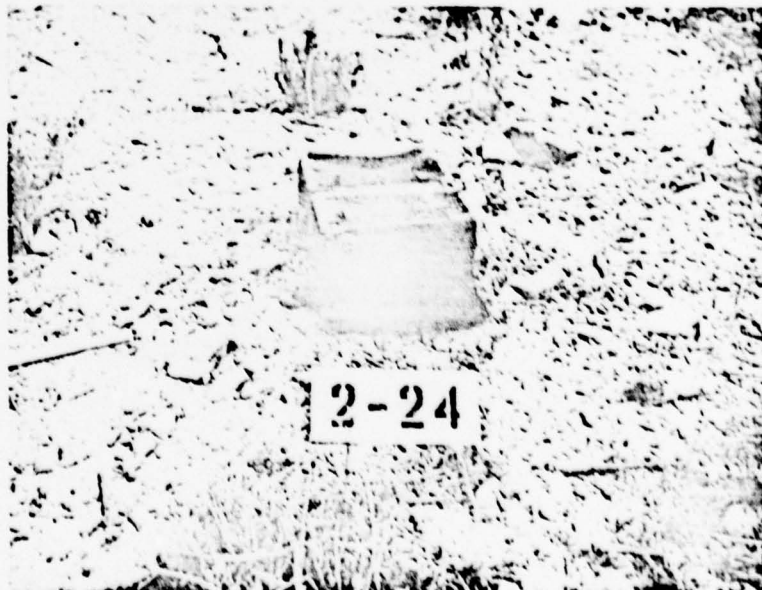
Thrown 90 feet. Se-
verely damaged.

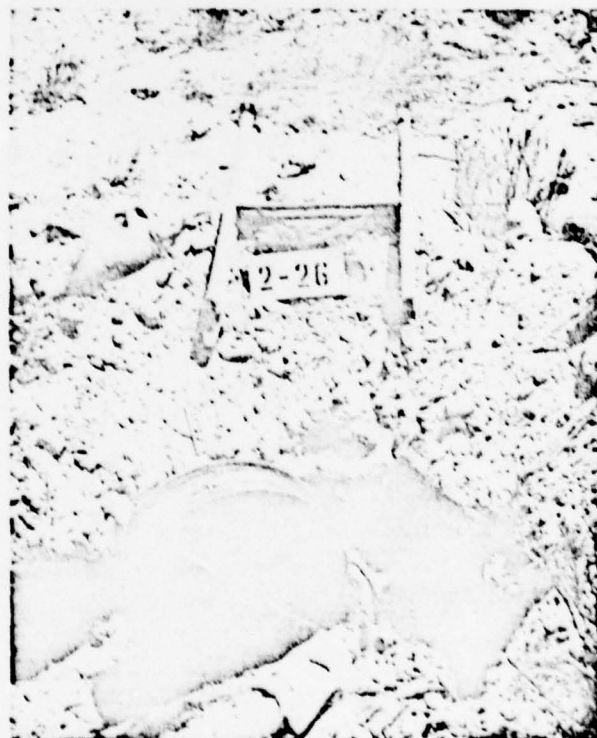
Drum broken from reel. Both
thrown 40 feet. Wire insula-
tion charred.
